PROPERTY RISK CASE STUDY

CONSIDERING RISKS IN THE LIGHT OF FUTURE EVENTS

This case study looks at a landslip, where part of the subject property's garden slipped into the neighbouring garden.

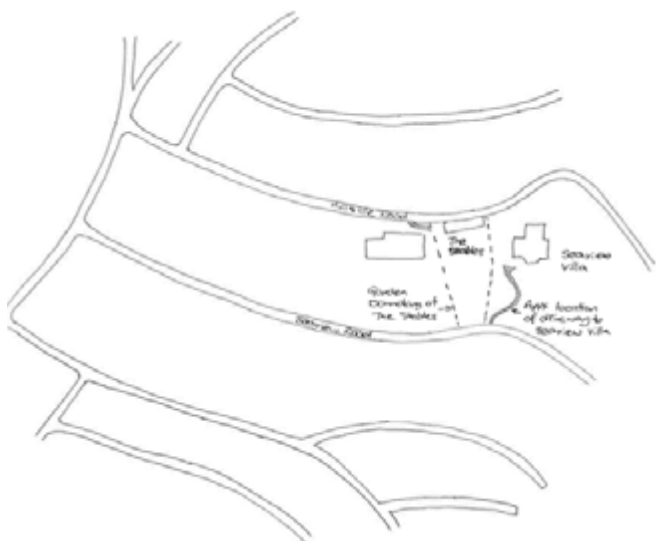
Plan 1

However, the immediate neighbour on the other side, which we will call ‘Seaview Villa’, is actually accessed from Seaview Road, the lower road at the bottom of the garden of ‘The Stables’ (see plan 1).

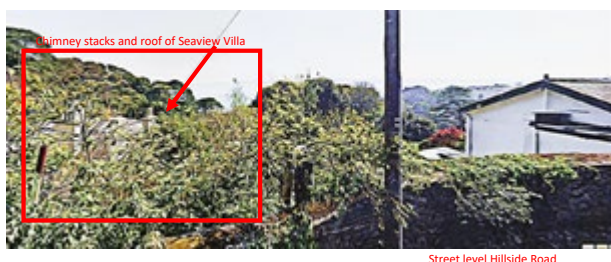
When viewed from Hillside Road only the roof line of Seaview Villa is visible – no mention of the different ground level was noted in the report. See Picture 1 showing the roofline of Seaview Villa.

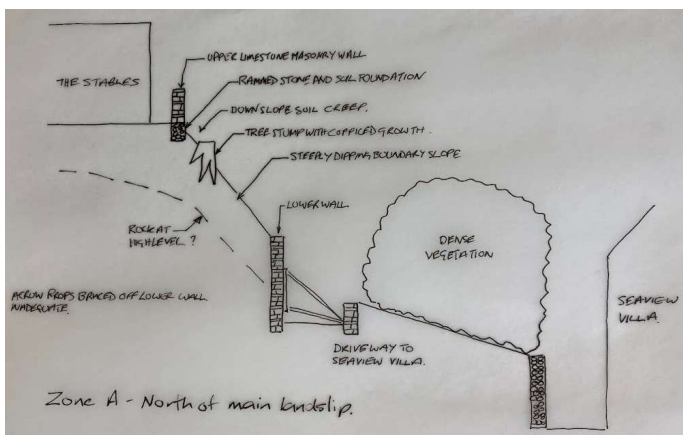
- Zone A – this was north of the main landslip – the upper wall is a limestone rubble wall and leans towards The Stables and has in the past been buttressed. The surveyor could see and noted this in his report.

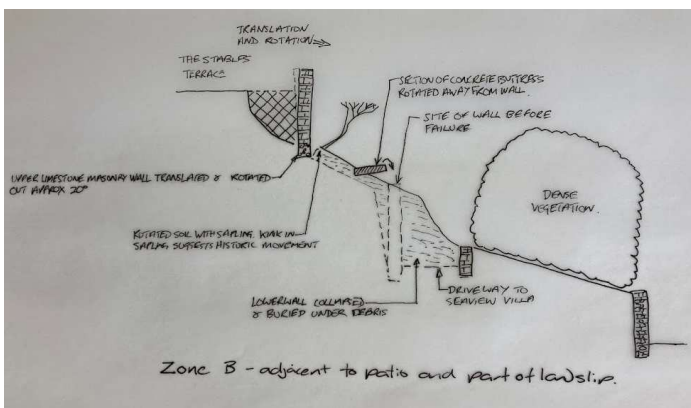
- Zone B – 5-6m section which formed part of the landslip and borders the patio of The Stables. The upper wall here is also a limestone rubble wall covered with thick vegetation and with planters in front. The surveyor could not see this wall clearly.

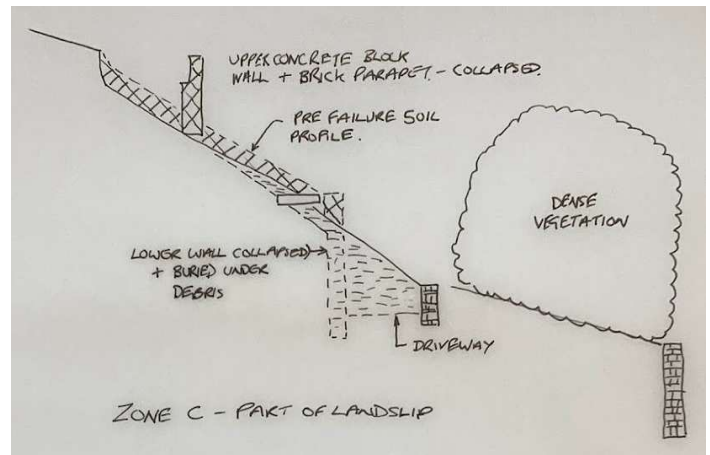
- Zone C – 7m section which formed part of the landslip. The upper wall here was a concrete block wall, built on top of the limestone rubble wall of Zones A and B, approximately 15 blocks (2.3m) high at the southern end of Zone C and extending to appx 2.9m high at the northern end of Zone C, having been heightened further by the use of good quality red bricks. There was considerable ivy growth over the wall in this Zone. (For clarity, the height is from within the grounds of Seaview Villa, not The Stables). The mature flower beds in front of this section of the wall meant the surveyor could not see this clearly.

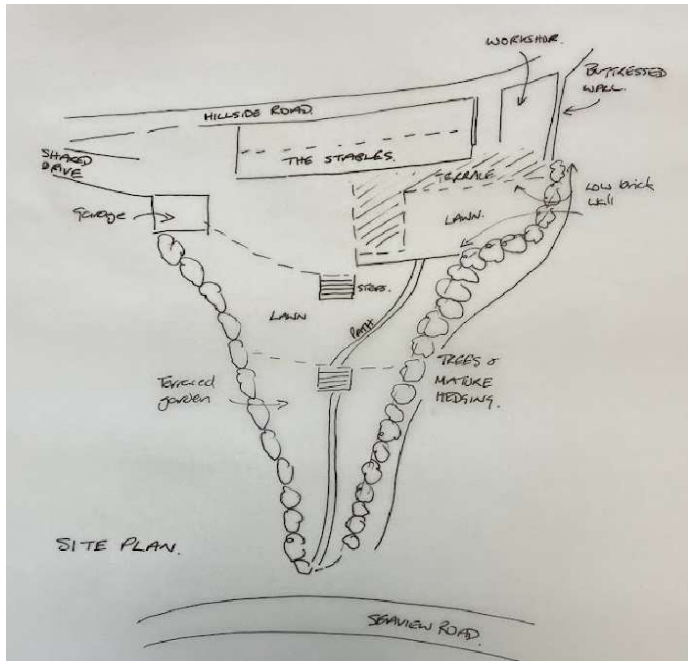
The next point addressed was if the surveyor should have commented more on the condition of the retaining walls. But (and again the engineer’s report confirmed this) it was not possible from within the curtilage of The Stables to even determine that the other walls were retaining walls along the boundary with Seaview Villa, never mind the construction, appropriate design and condition of them. The site notes included an excellent site plan that clearly shows mature trees along the boundaries on either side. (see plan 2).
