# TECHNICAL BULLDINGS BETTER TECHNICAL BULLETIN FOR RESIDENTIAL SURVEYORS

# **CAVITY WALL TIE FAILURE**

# THE TECHNICAL BULLETIN

FOR RESIDENTIAL SURVEYORS

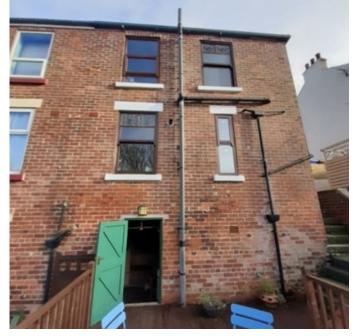
The photographs to the right demonstrate some of the classic signs of cavity wall tie failure:

- Horizontal cracking high up on the exposed south westerly elevation.
- The property was built in the 1930s.
- It was made using black ash mortar.
- · Just visible within the cavity (which could be seen

through the cellar door entrance) was a wall tie with visible rusting.

Figure 3: South westerly elevation

Figure 4: Closeup of cracking evident on top floor

Figure 5: Wall tie with visible rusting

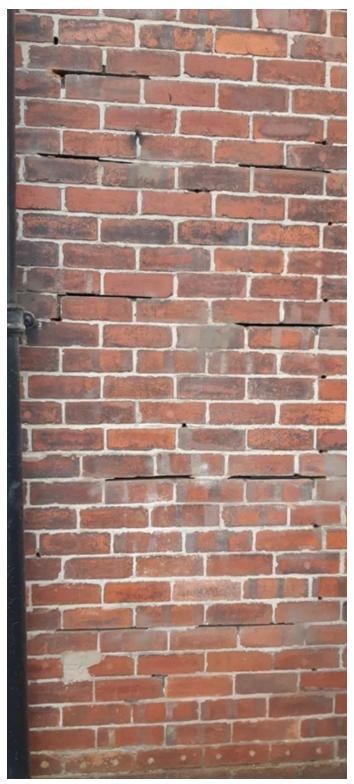
2. Once all the old tie locations are marked, the technician uses a heavy-duty angle grinder to grind through the mortar and then into the head of the tie itself, chopping the tie down to about two-thirds of its original length. A vacuum attachment removes the debris created by the grinding. This is important as it prevents debris from falling into the bottom of the cavity, potentially causing damp bridging issues in the future. This process leaves a wall with a very pronounced series of horizontal chases in

the outer leaf wall, as can be seen in the next image.

Figure 8: Horizontal chases in outer leaf wall

3. The new remedial wall tie holes are drilled into the mortar where the new ties will be installed (also shown in the image above). The technician drills the holes into both the outer and inner leaf at a slight upward angle, meaning any water that gets onto the new ties will gravitate toward the outer leaf. Brick-Tie used a 'Helifix' remedial tie with a helical twist along its full length. This helix acts as a repeating drip feature and provides an excellent key for the resin. For several reasons, the holes are drilled into the mortar, rather than the centre of each brick (as many textbooks state). By drilling the mortar, the rear of the brick does not shatter which can occur when drilling through brick and blocks. This approach prevents a build-up of debris in the cavity which often results in damp and bridging issues, particularly for properties with existing cavity wall insulation. When the wall is repointed, if repointed well (Brick-Tie technicians use careful colour matching dyes in their mortar) the visual aesthetic of the house is maintained, and the property doesn't have the polka dot appearance that some properties have after wall tie replacement. Finally, the mortar is softer than brick which reduces the amount of vibration exposure produced during drilling, leading to safer long-term health outcomes for Brick-Tie's technicians, helping avoid Hand Arm Vibration (HAV) related injuries, like vibration white finger.

4. The remaining old wall ties are 'isolated' to prevent future issues. This is essential because there may be a small wafer of old tie left in the outer leaf, which will corrode and expand in the future. The chases (horizontal holes left by the angle grinder) need to be re-pointed without re-encapsulating the remaining tie section in mortar, where its continuing corrosion would otherwise cause new cracking. Although the new wall ties would hold the inner and outer walls together, the rusting old ties could still cause issues with expansion and cracking. As such they are 'isolated'. There are many methods of doing this, but a common and efficient method is cutting pieces of plastic DPC and creating an isolator hood that is pushed into the gap to encase the old tie and prevent new mortar from touching the tie. In effect, the remaining section is left in a void - an expansion pocket, into which the slight growth of the thin section can expand, without being constrained. This is then over-pointed. The correct and diligent treatment of the old ties is the most frequently neglected part of wall tie corrosion projects. However, the basic methodology is proven to work and has been used for over 35 years.

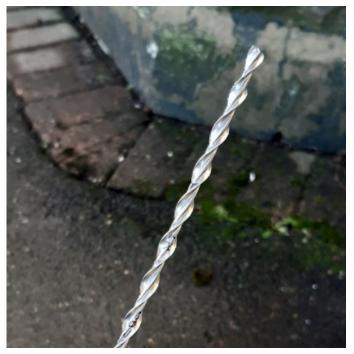
Figure 10: Helifix remedial wall tie

There are many different types of remedial wall tie, for example mechanical, friction fix, grouted, and chemical fixings. Bryan Hindle explained that most available systems are acceptable, adding "The surveyor or specifying specialist should consider each project on merit and use the most appropriate tie for that situation. There is no such thing as one-size-fitsall. The most important issue is not the wall tie, brand or model – the technician is the crucial element – skill, knowledge, on-site testing and most of all engagement in the success of the work is what makes or breaks any remedial work."

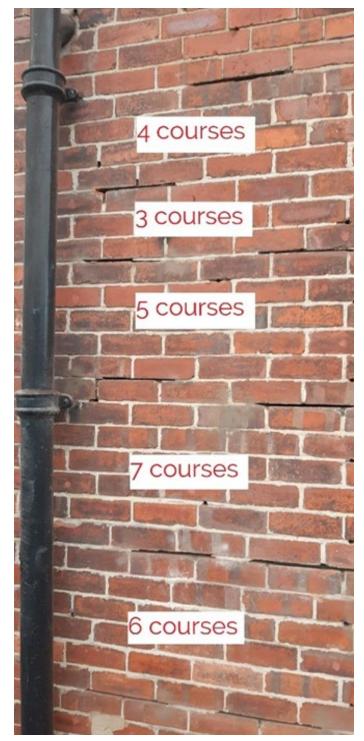
Textbooks often state wall ties are usually at 450mm/6 brick course vertical intervals; however, this is not always the case. This was demonstrated in this case study with one small section of the wall having wall ties at intervals of 3,4,5,6 and 7 brick course intervals! The original builder of the property may have miscounted, forgotten to add a tie, or maybe even dropped one down the cavity and not been bothered to climb down their ladder to get another!

If you come across horizontal cracking when inspecting a property, don't be fooled into thinking that it cannot be cavity wall tie failure if it doesn't correlate perfectly to 6 brick courses.

Figure 14: Inconsistent wall tie brick course intervals

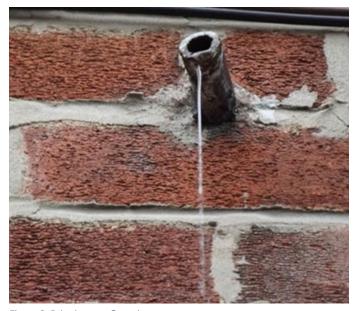
**Damaged ball valve** - the ball valves allow water to enter the tanks through the inlet pipe to refill the tank when water is drawn off. When the water reaches a certain level the ball valve will close the inlet pipe. When it fails, water will continue to enter the tank and will lead to the tank overflowing. This could be slight and simply a drip from the overflow pipe which should be noticed by the property owner or indeed surveyor and resolved or the fault can be more serious resulting in a sizable leak and significant damage.

Figure 2: Dripping overflow pipe

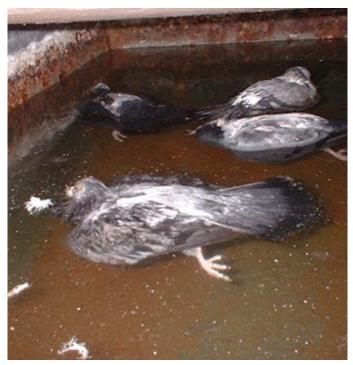
**The internal condition of the tank** – this will have a direct impact on the quality of stored water and conditions may arise that encourage the proliferation of pathogenic bacteria, including Legionella. Tiny, suspended solids and dissolved solids in the mains water settle and collect at the bottom of the tank as sediments which serve as nutrients that encourage bacteria growth.

Figure 3: Contaminated water tank

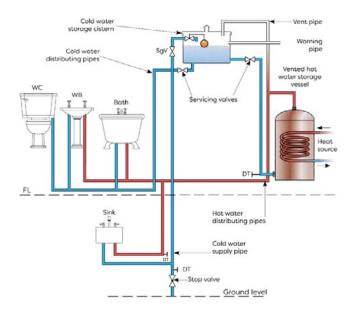
Figure 5: Indirect cold-water system with hot water overflow to the coldwater  $\ensuremath{\mathsf{tank}}$

However, some older properties will have a system where the overflow from the hot water tank is to the cold-water storage tank in the loft (see figure 5).

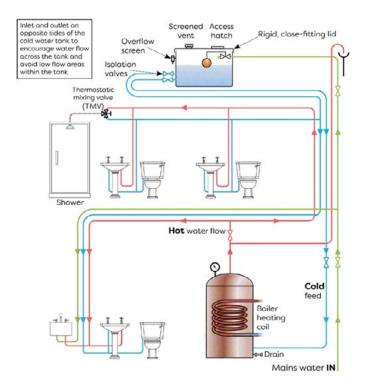
A modern indirect cold-water system will have an overflow from the hot water storage tank as shown in the diagram below.

Figure 4: Modern indirect cold-water system with overflow from hot water storage tank
