# TECHNICAL BULLETIN

FOR RESIDENTIAL SURVEYORS

## GRENFELL TOWER INQUIRY PHASE 1 REPORT

## WHAT WE HAVE LEARNT FROM PHASE 1 OF THE GRENFELL TOWER INQUIRY

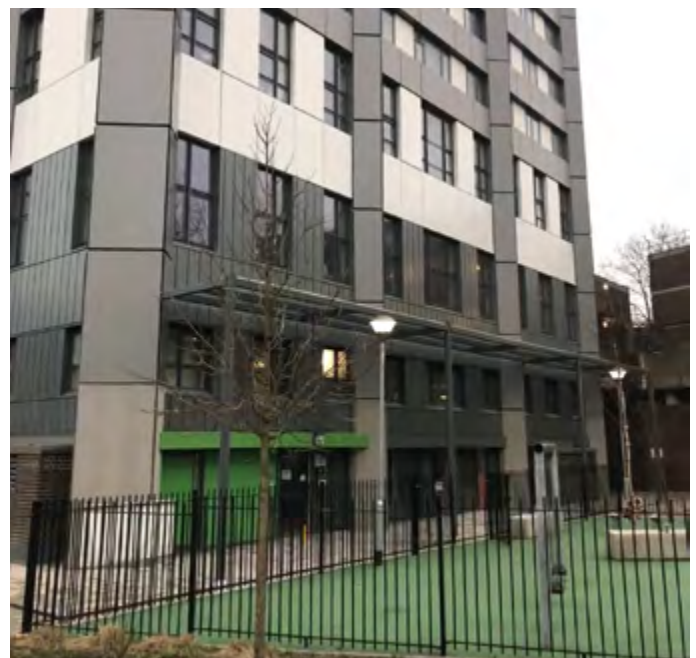
Figure 1

The most significant change to the building, and most referred to, was the refurbishment carried out between 2012 and 2016. During that period Grenfell Tower underwent substantial changes affecting both the outside and the inside of the building. As we all know, it incorporated the over-cladding of every storey of the existing building with a new insulation and rainscreen cladding system.

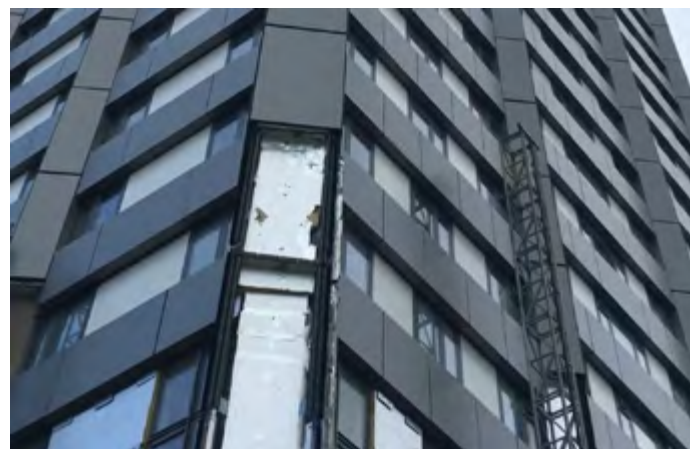
Figure 2

The outer layer of the new external façade covered the existing concrete spandrel panels and the columns. This façade comprised ventilated rainscreen panels made of aluminium composite material (ACM) pre-fabricated into 'cassettes' which are hung on steel or aluminium supports fixed to the concrete structure.

These systems are designed to protect a building from water, with the exterior surface providing the original protection layer. Some water will inevitably get through the outer layer and will seep through to the inner surface of the cladding where it will drain down via gravity. The cladding material

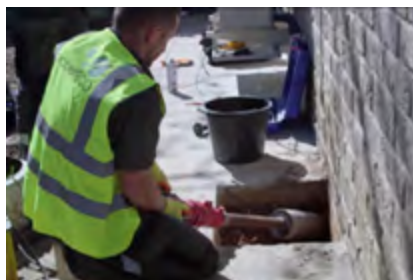
The most preferred method for remediation is using a radon sump. This is where a void is created beneath the property, which then becomes the lowest point of pressure. Any radon present in the soil will be drawn towards the void by suction, created by an electric fan. The gas can then be safely vented away with the assistance of a powered fan, through an exhaust pipe. The exhaust pipe will then vent the harmful radon gas away from the property. It's important that the exhaust pipe is not located near any doors or windows to ensure that the radon gas is not vented back into the building.

Figure 1 - radon sump installation

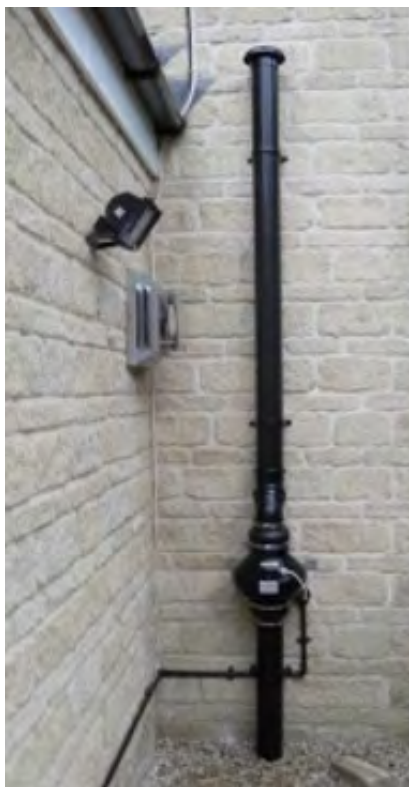
Figure 2 - example of exhaust pipe

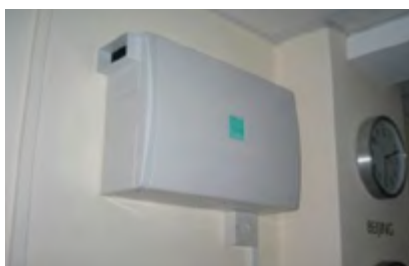
The second form of radon mitigation is installing a positive pressure system. This involves installing fans inside of the property, either in the loft, attic or, if the roof void is not present, the fan can be installed on the internal side of the external wall. This form of positive pressure system works by drawing air from outside of the building and then pushing clean filtered air back into the building. This has the effect of pushing 'stale' air out of the property.

Figure 3 - example of a positive pressure system

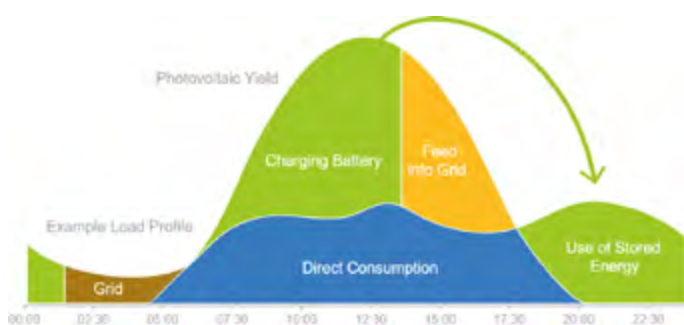
Figure 3

In figure 3 below, the small, brown section demonstrates what the household will need to use from the grid before the sun rises. When the sun rises the PV panels can generate energy which is divided up to charge the battery, used for direct consumption, as well as any surplus exported to the grid. In the evenings when peak household demand occurs, the energy stored earlier can be used.

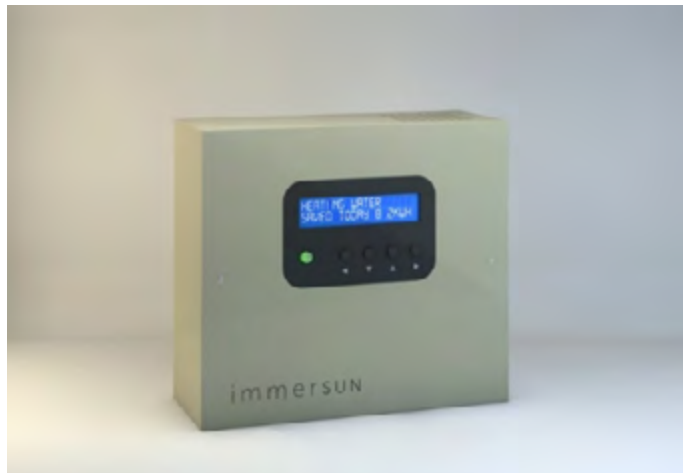
If a PV diverter is present, it is likely to be in the same place as the inverter for the PV system that converts the direct current from the PV to alternating current for the dwelling. Remember, a hot water cylinder is required for the property to benefit from a PV diverter. The calculation would reduce the energy required for the water heating.

Figure 5 – example of a diverter

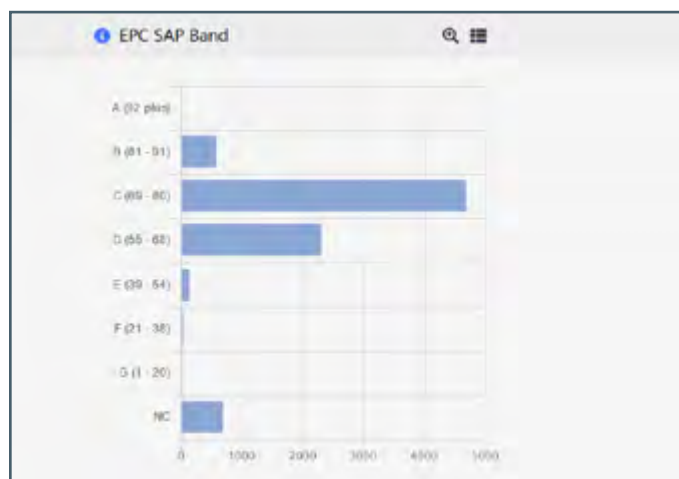
Figure 1

Below is a snapshot of overall SAP bands, based on a stock of 8,000.

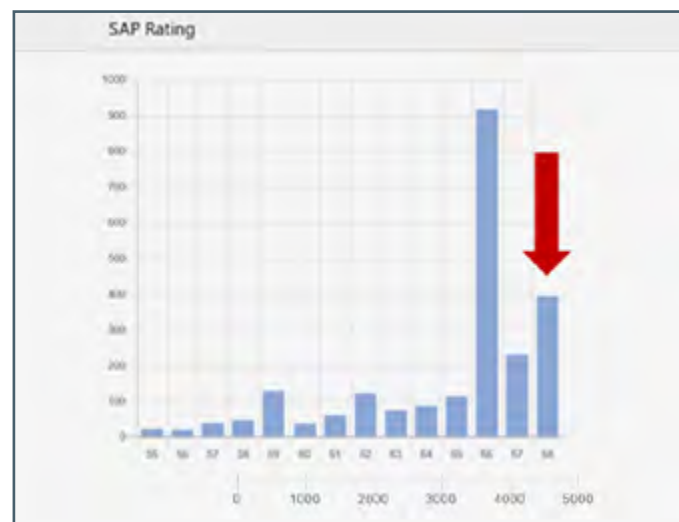
Figure 2

As each SAP band is broken down into specific ratings from 1-100 this information can be used as a starting point to interrogate the data to find opportunities. Some of the properties in SAP band D (55-68) will only be one or two SAP points away from reaching band C. This means you can identify properties that may only require minor measures to push them into the higher band. If we look at figure 2 below, we can see that there are nearly 400 properties which will move into band C with just one more SAP point.

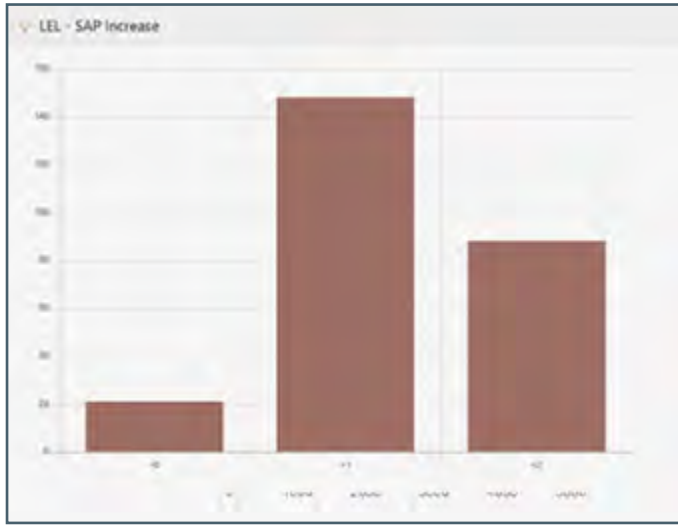
them into band C. The recommended measures can be analysed to locate the measures that achieve the lowest cost per SAP point increase. Figure 3 below shows one of the many available measures in Intelligent Energy.

This recommendation is for Low Energy Lights (LEL). It shows there are over 140 homes which will benefit from a 1 SAP point gain and around 90 properties will benefit from 2 SAP points if 100% low energy lights were installed.

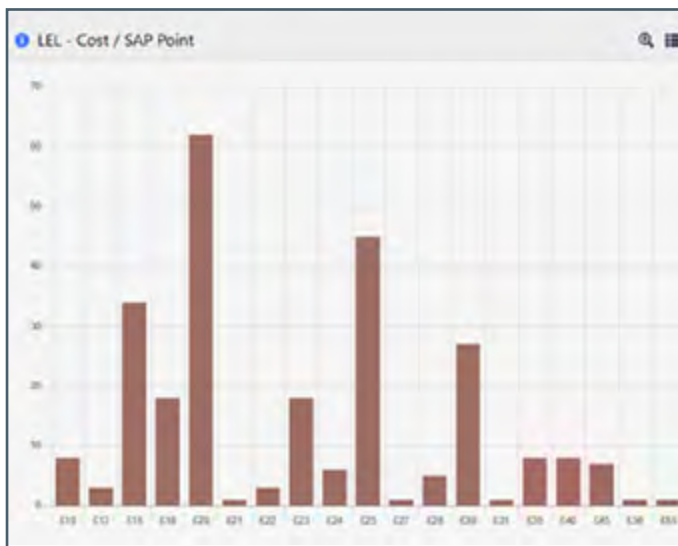
Figure 4

The chart in figure 4 shows the cost per SAP point for low energy lights. This is the install cost of the recommendation divided by the SAP point change. A lower figure means the measure would be more cost effective in terms of a SAP point improvement. This SAP point change is a cumulative change and assumes that other recommended measures have been installed.

If you choose to issue low energy bulbs to the tenants of these properties (or you are confident that they already have them and the data is incorrect), you can now export the list of properties, update the data and recalculate within your asset management system. This will take over 200 homes into band C in a cost-effective way.
